**April to December 2023 Geotechnical Inspections and Monitoring Summary**  
**Cell 20-1, Clean Harbors Lambton Landfill Site**  
**Corunna**

**Site Photographs**  
**Cell 20-1 2023 Geotechnical Inspections**  
**Clean Harbors Lambton Facility Landfill,**  
**Corunna**

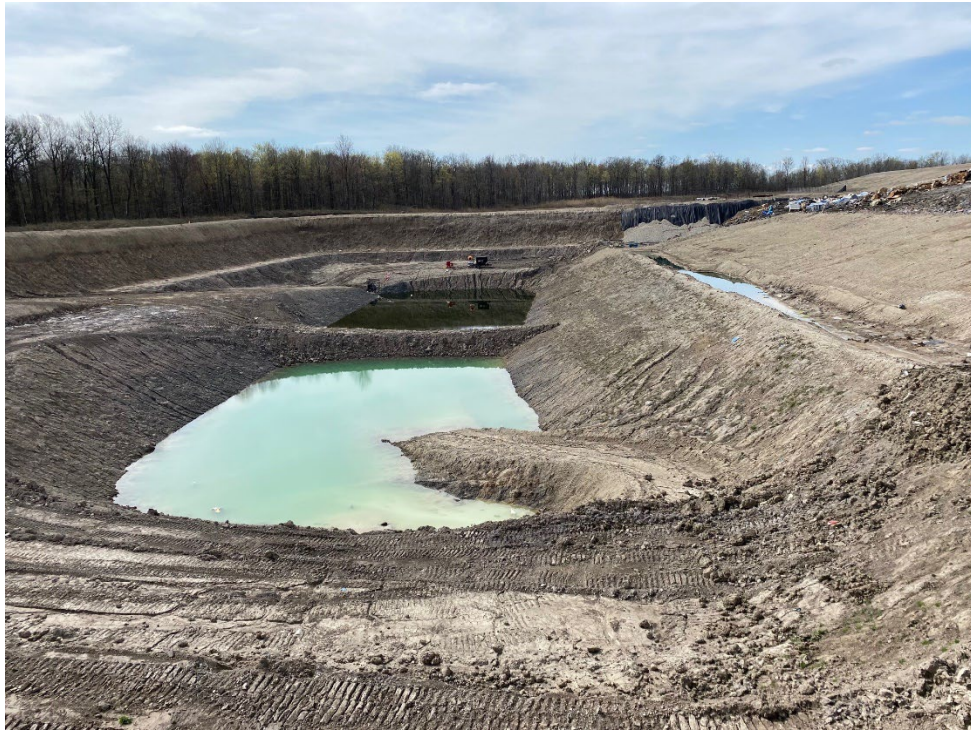
Photo 1- Cell 20-1 looking south, April 19, 2023.

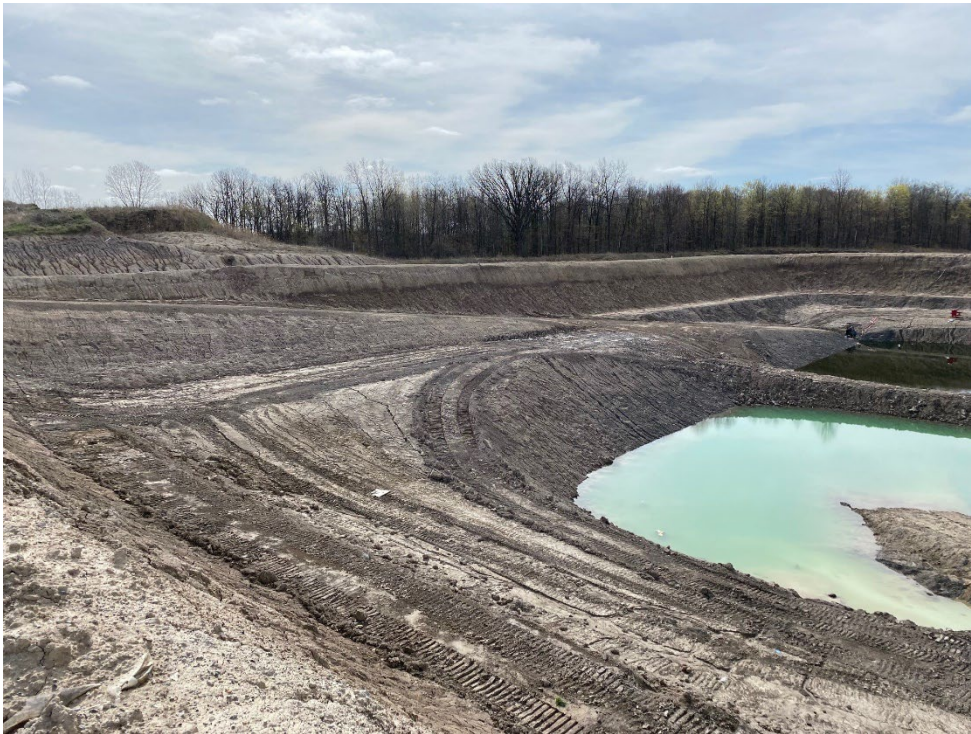
Photo 2- East side wall of Cell 20-1, April 19, 2023.

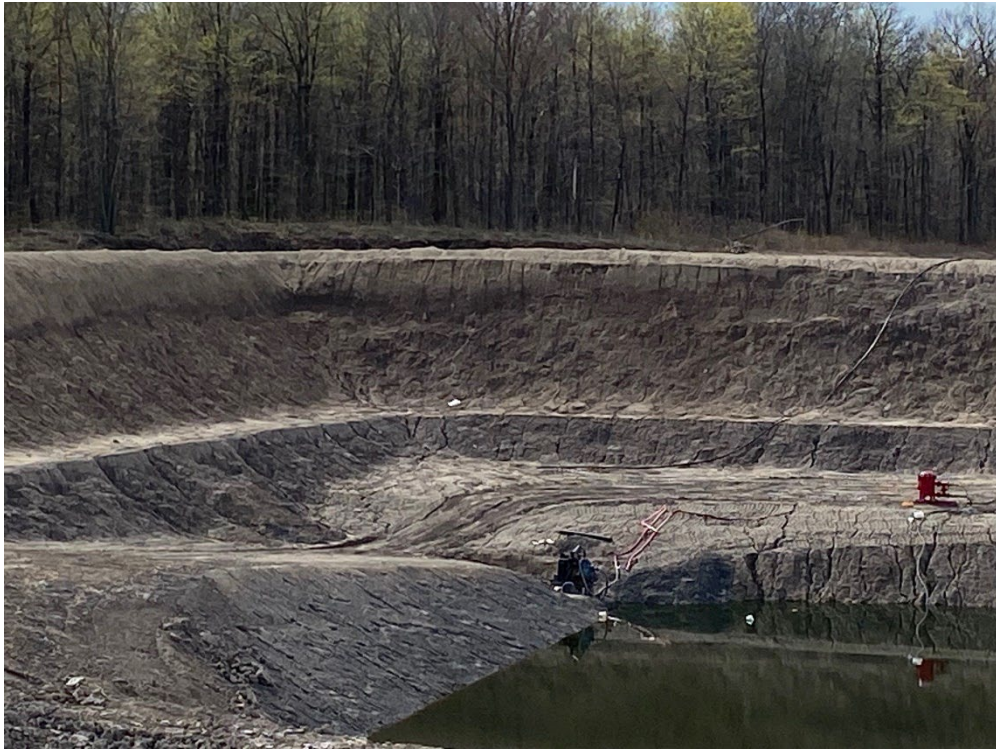
- Dry site conditions.
- All side slopes were visually stable.
- The shallow groundwater seepage zone in the southeast corner of the cell was dry.

Photo 3- Cell 20-1 Southeast corner, April 19, 2023.

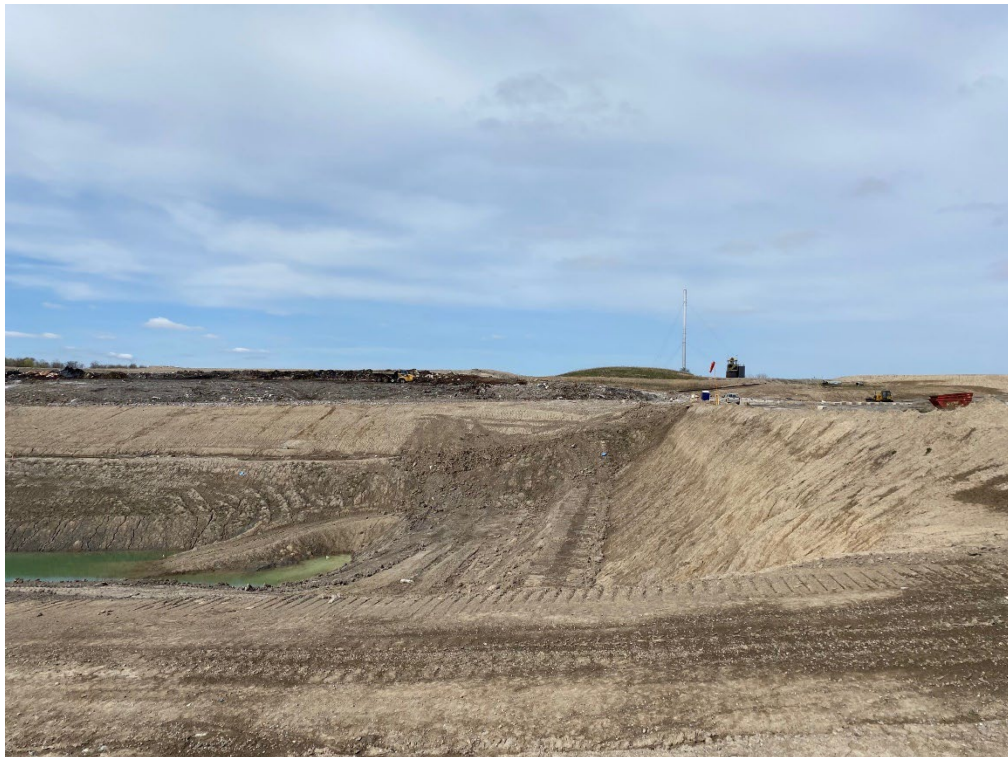
Photo 4- North side wall, April 19, 2023.

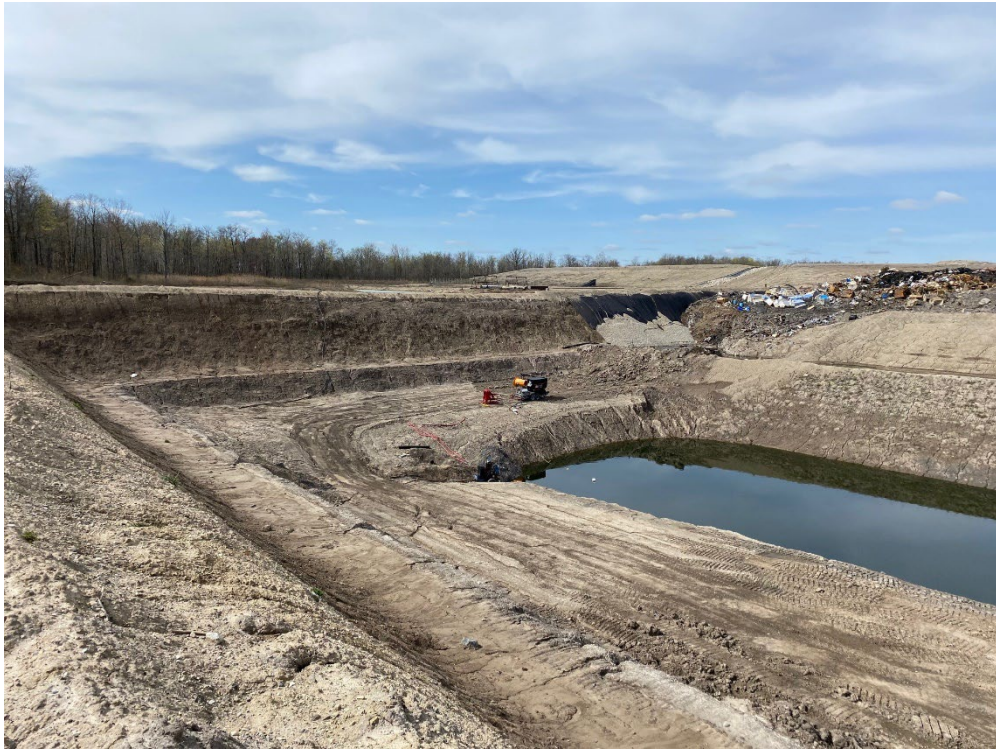
Photo 5- South side wall, April 19, 2023.

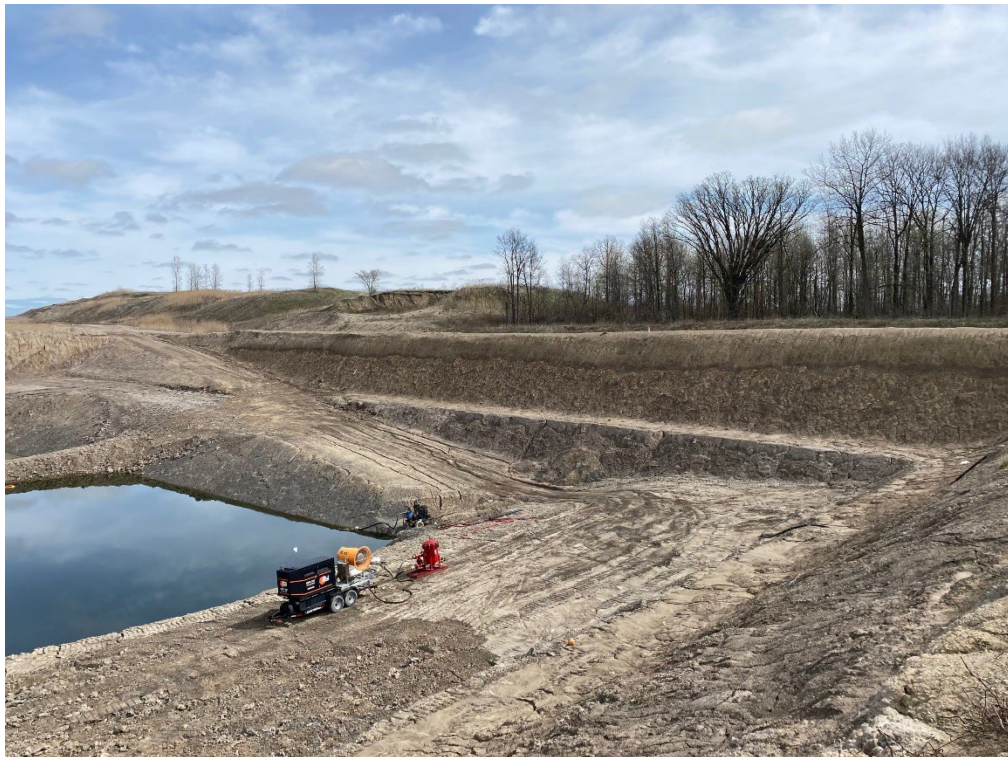
Photo 6- Cell 20-1, East side wall, April 19, 2023.

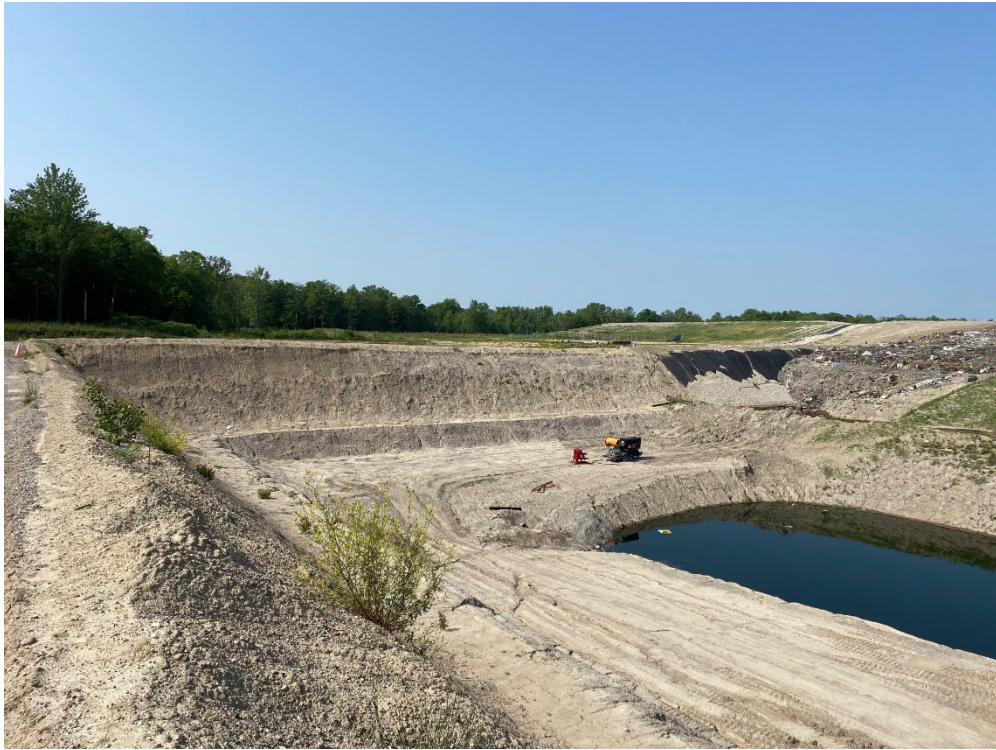
Photo 7- Cell 20-1, South side wall, June 21, 2023.

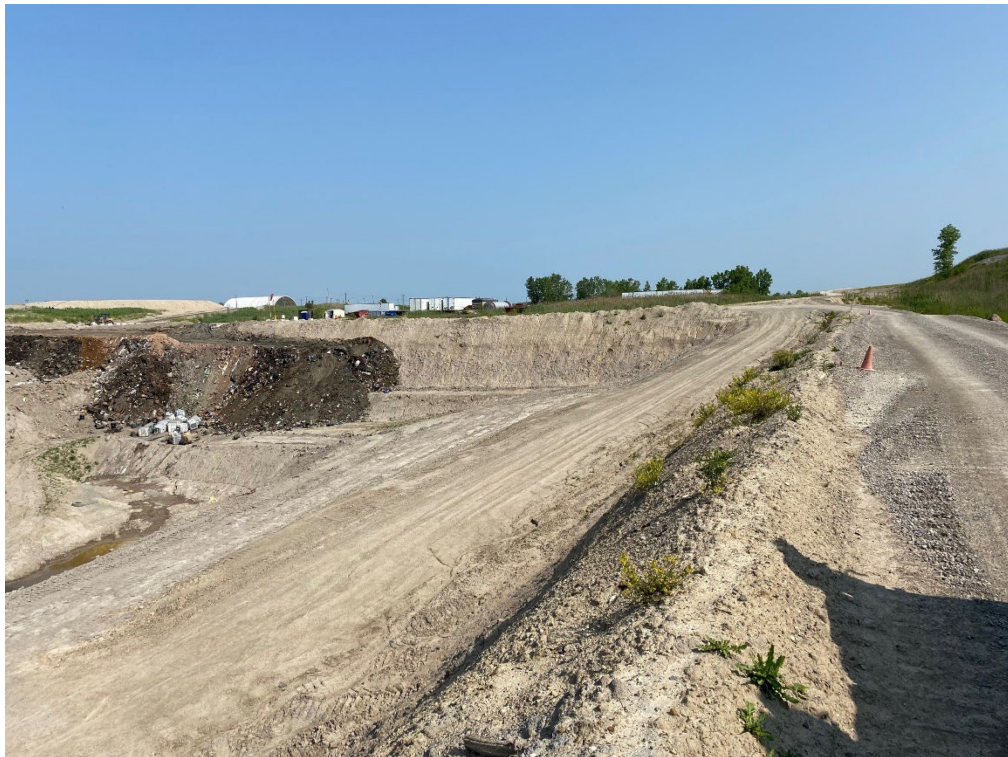
Photo 8- North side wall, start of waste placement, June 21, 2023.

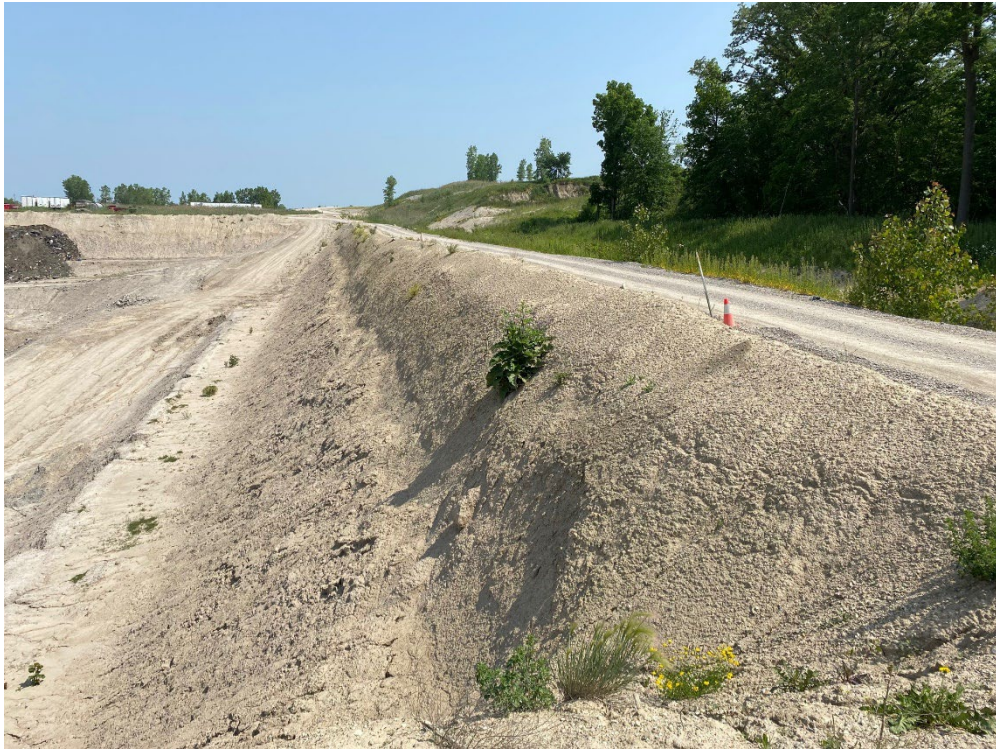
Photo 9- Cell 20-1, East side wall, looking north, June 21, 2023.

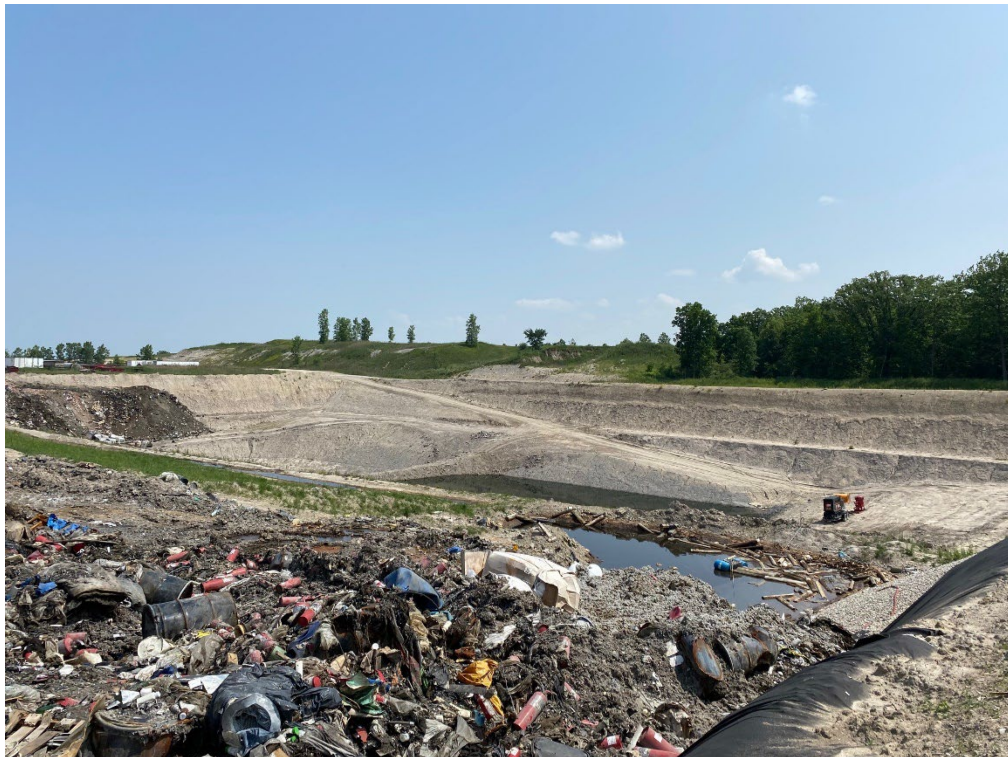
Photo 10- Cell 20-1, East and North side wall, looking east, June 21, 2023.

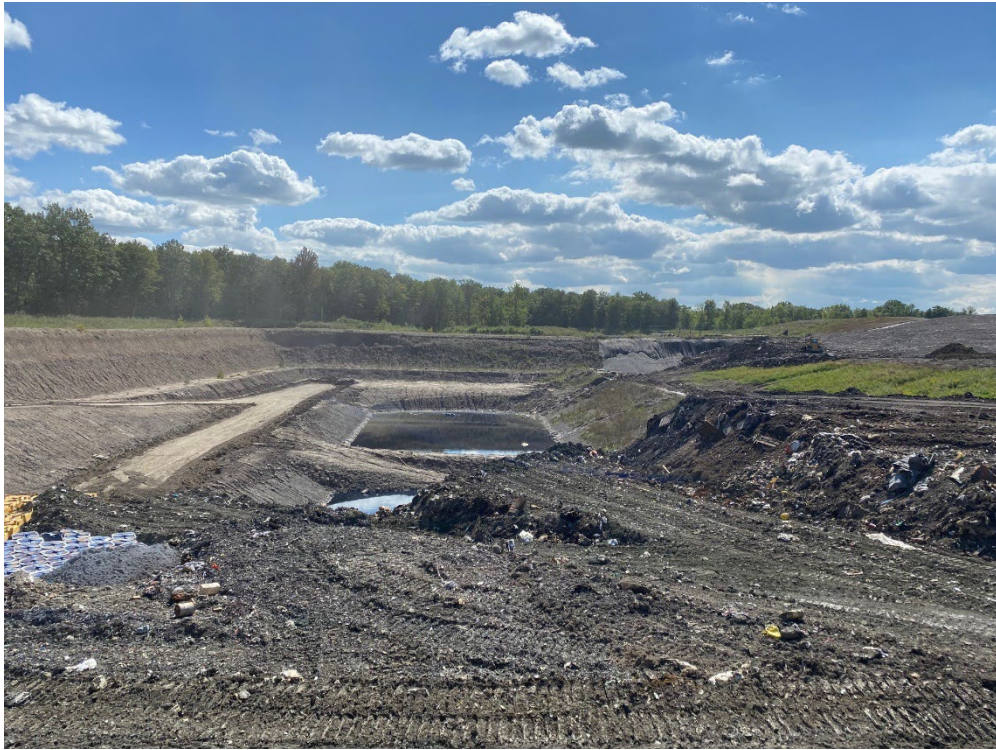
Photo 11- Cell 20-1, looking south. September 14, 2023.

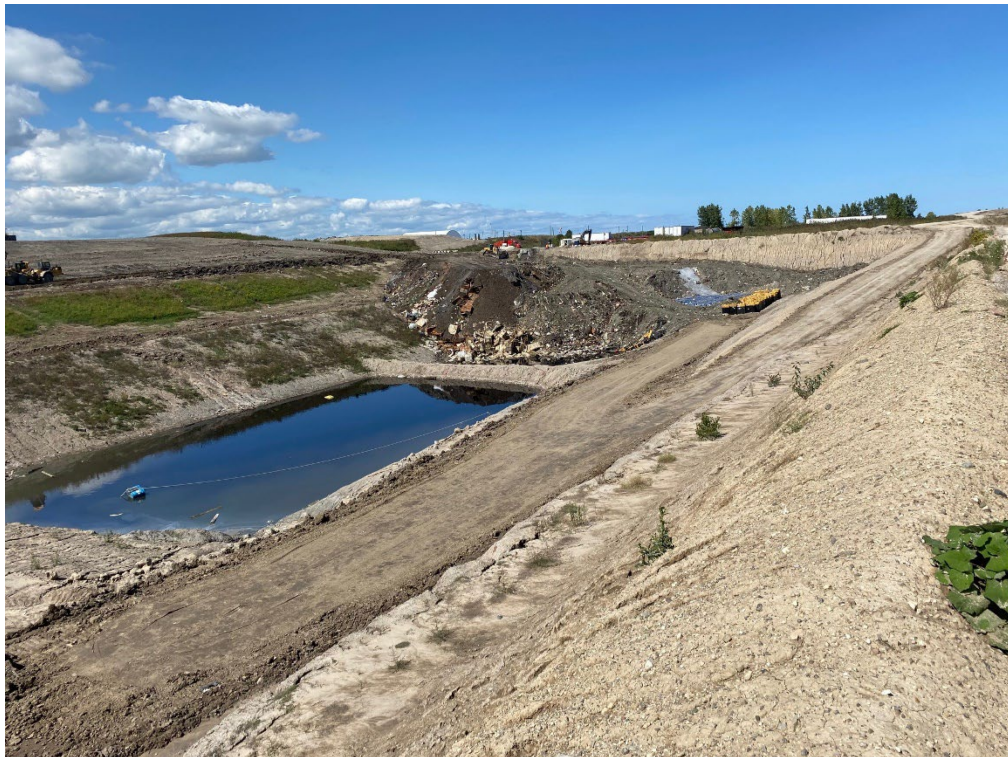
Photo 12- Cell 20-1, looking north, September 14, 2023..

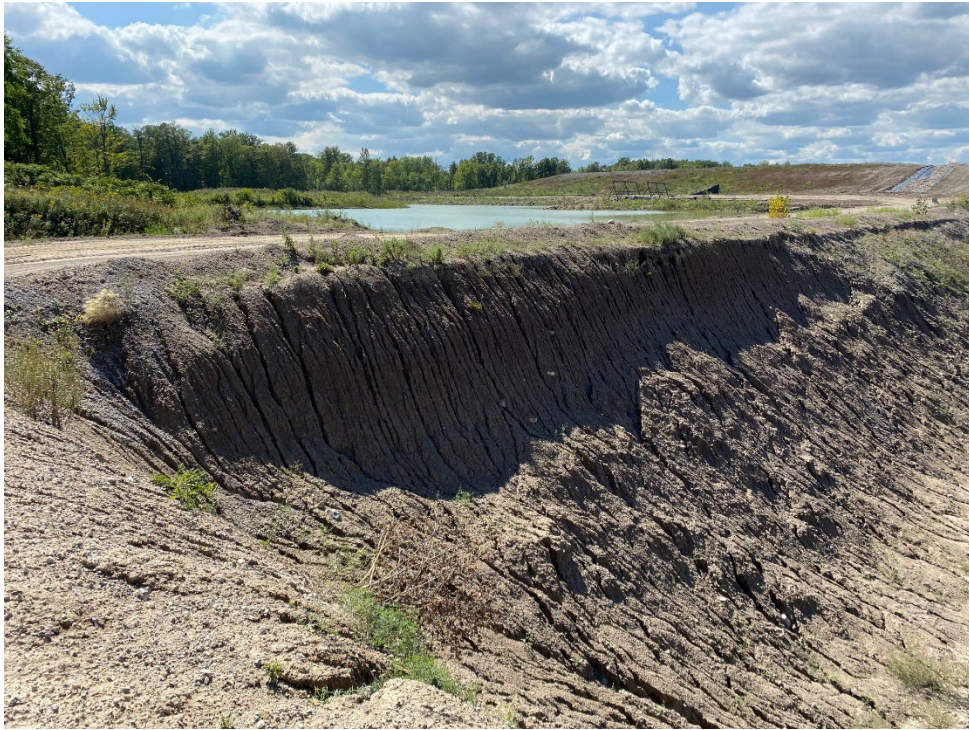
- Dry site conditions.
- All side slopes were visually stable.
- The southeast corner shows some sloughing from the top surface, but remains stable.

Photo 13- Cell 20-1, southeast corner, September 14, 2023.

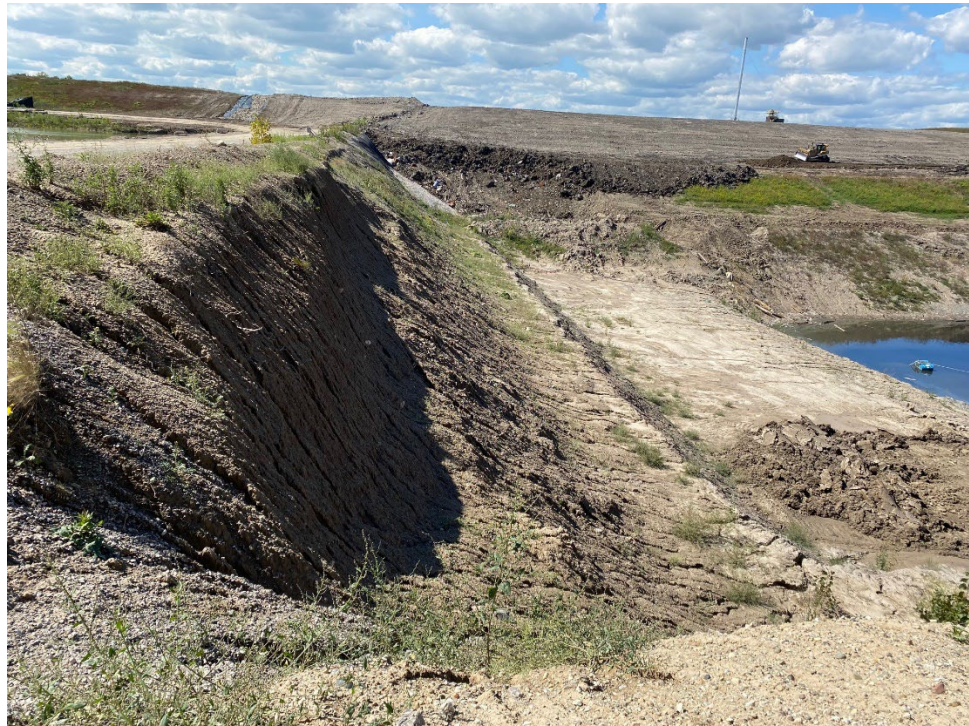
Photo 14- South side wall, looking west. Side wall sloughing, but stable, September 14, 2023.

- GHD has advised Clean Harbors to restrict heavy construction equipment from using the east and south perimeter gravel road, due to the ongoing sloughing of the upper side wall slopes in this area, and the narrow perimeter road in the southeast corner.

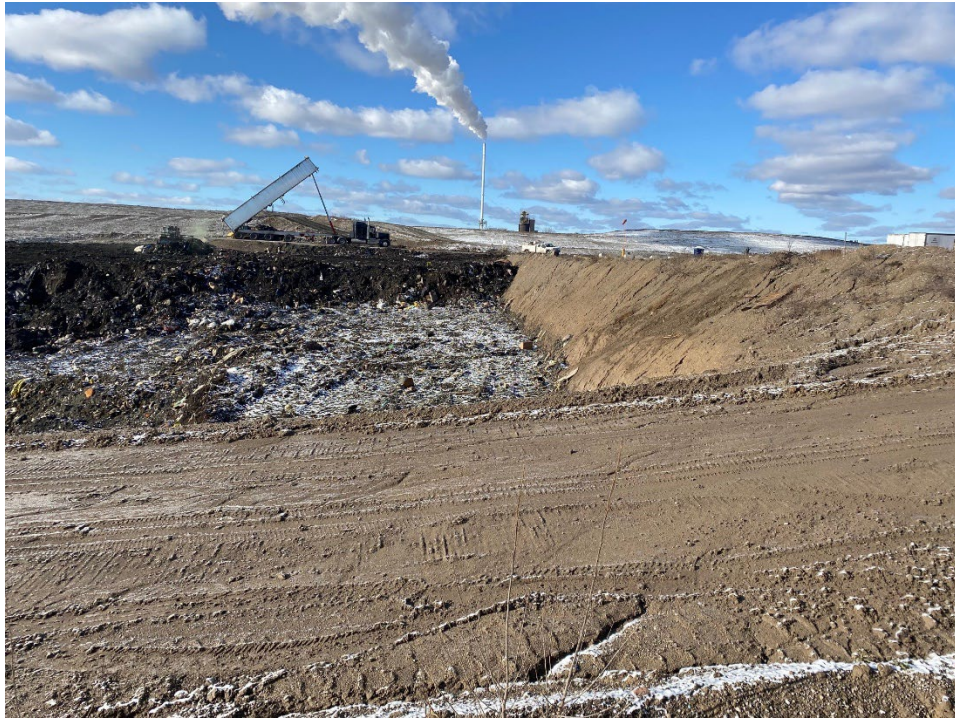
Photo 15- Cell 20-1, North side wall, looking west, December 19, 2023.

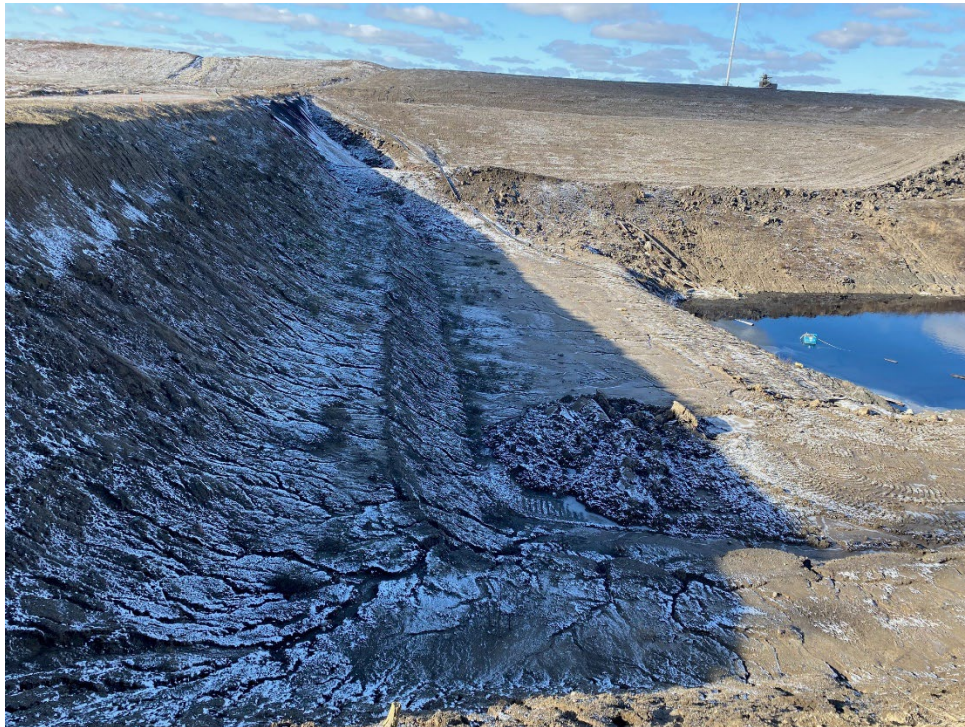
Photo 16- Cell 20-1 Southeast corner south side wall, looking west. Some sloughing and seepage from the southeast corner, December 19, 2023

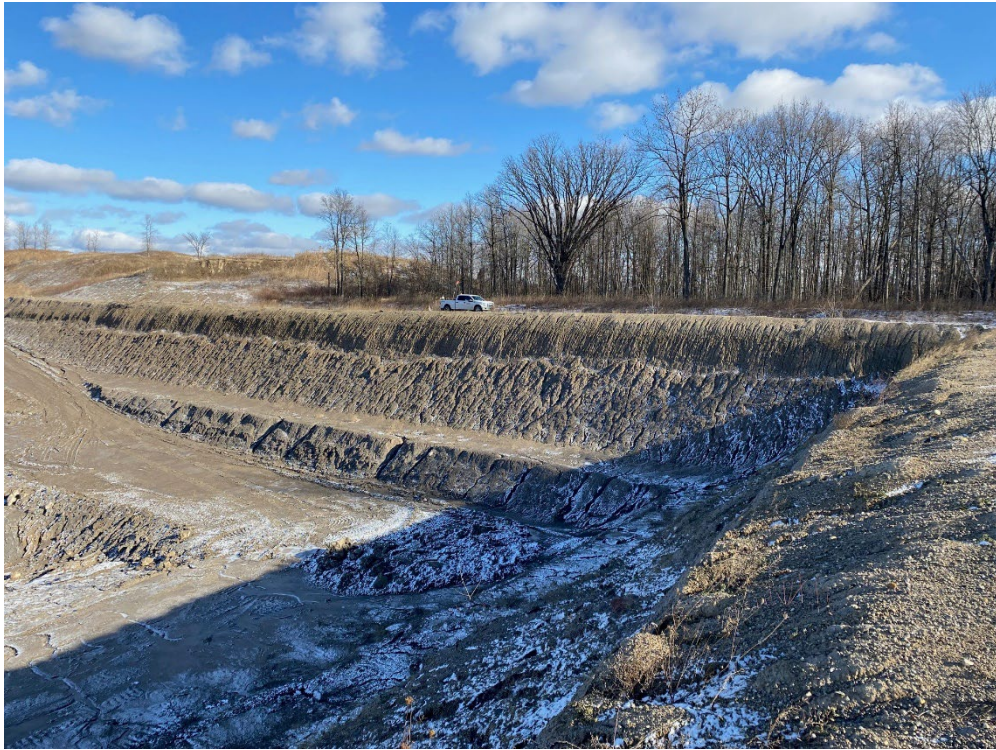
Photo 17- Cell 20-1 East side wall, December 19, 2023.

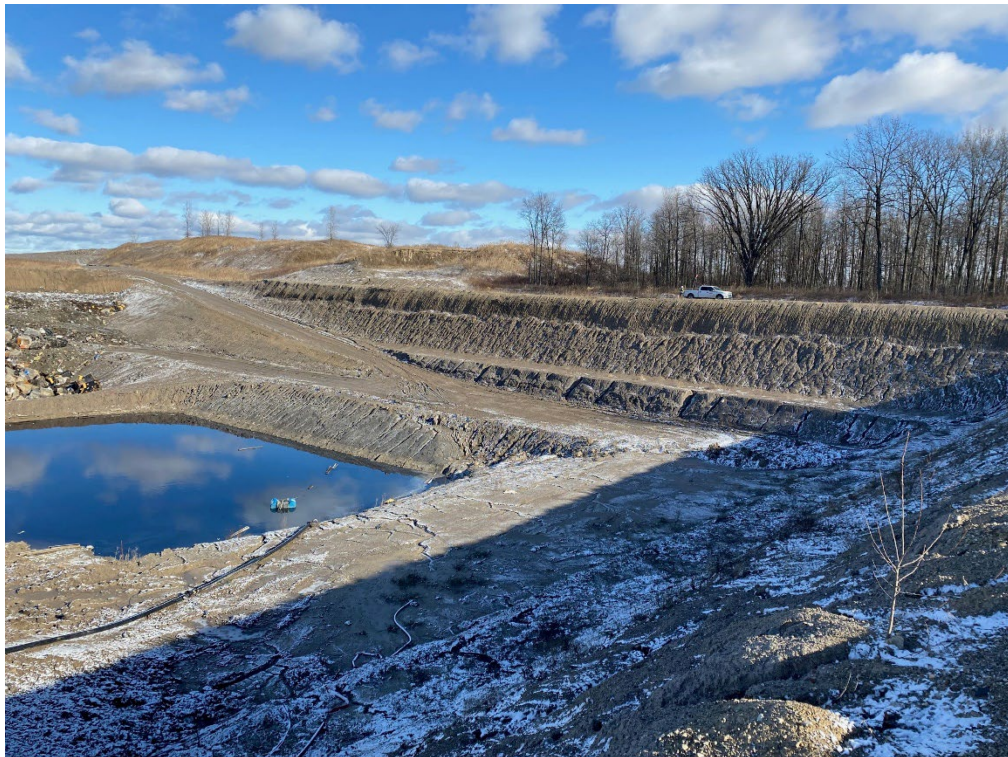
Photo 18- Cell 20-1, East side wall, December 19, 2023.

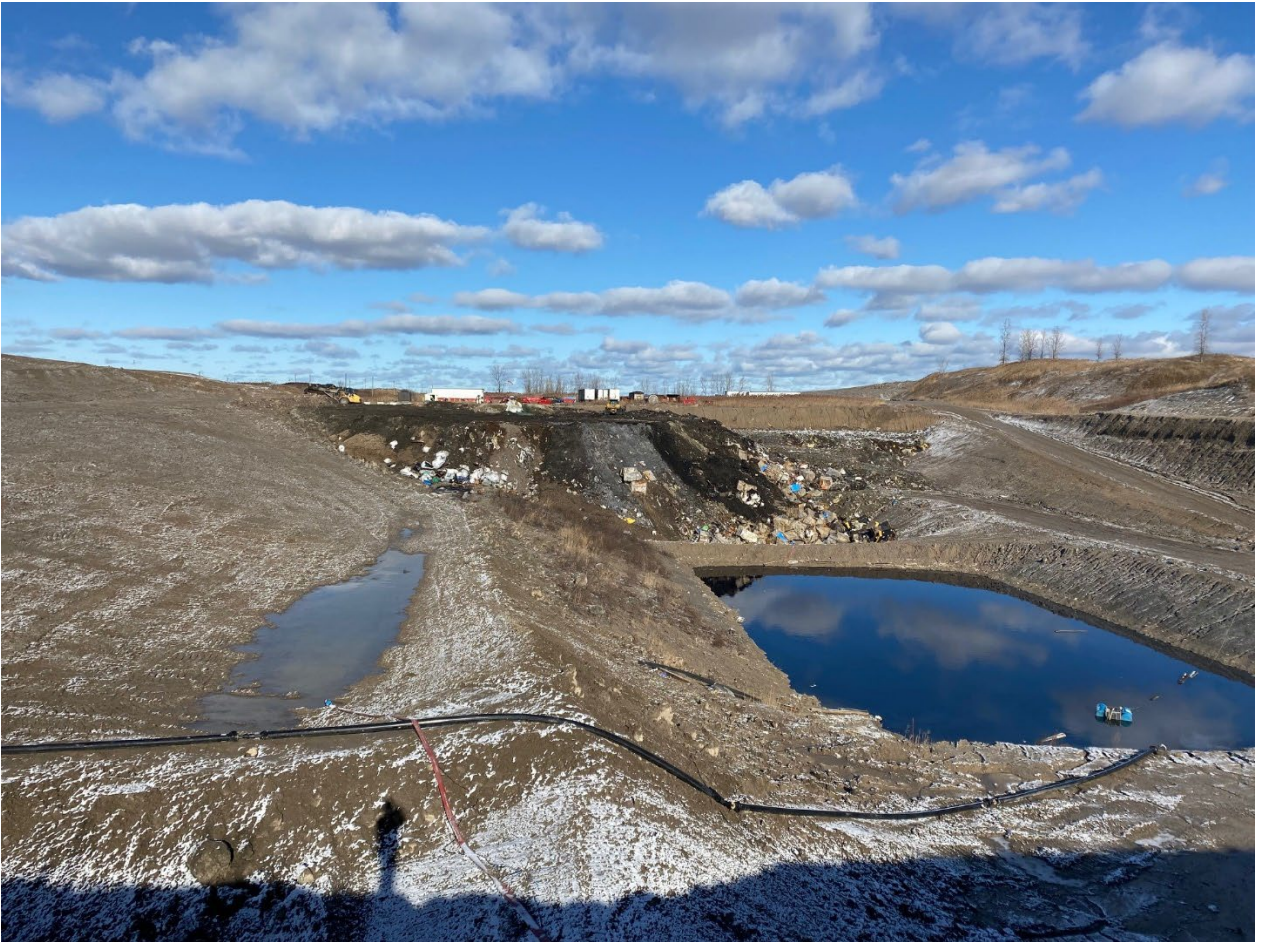
Photo 19- Cell 20-1, looking north, December 19, 2023.

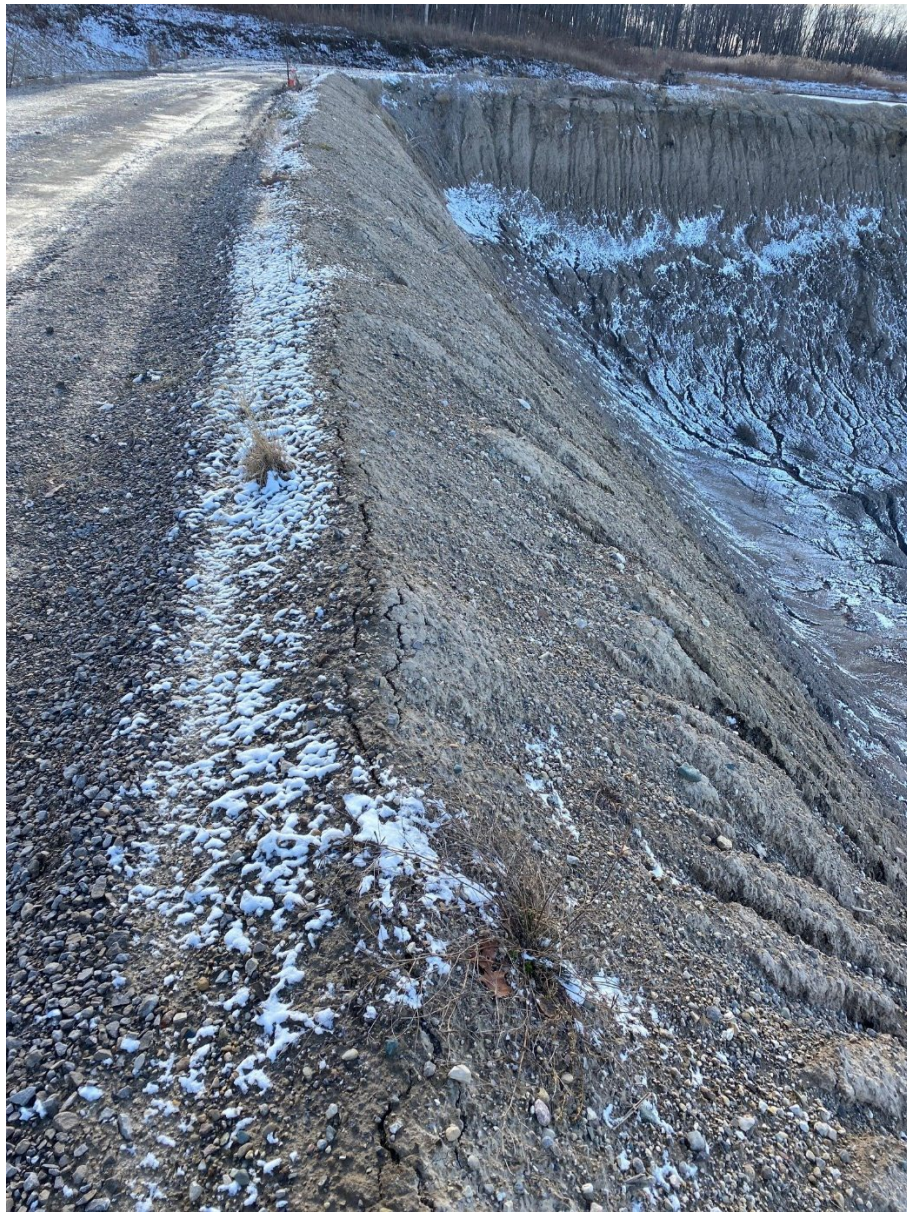
- Dry site conditions, with some surficial snow
- All side slopes were visually stable.
- Some evidence of groundwater seepage from the shallow seepage zone in the southeast corner of the cell.
- Minor shallow cracks running along the top of the east side wall, likely due to surficial sloughing and weathering of the exposed slope.

Photo 20- Cell 20-1 East side wall, looking south. Note minor cracking along the top of the slope, due to surficial sloughing, December 19, 2023

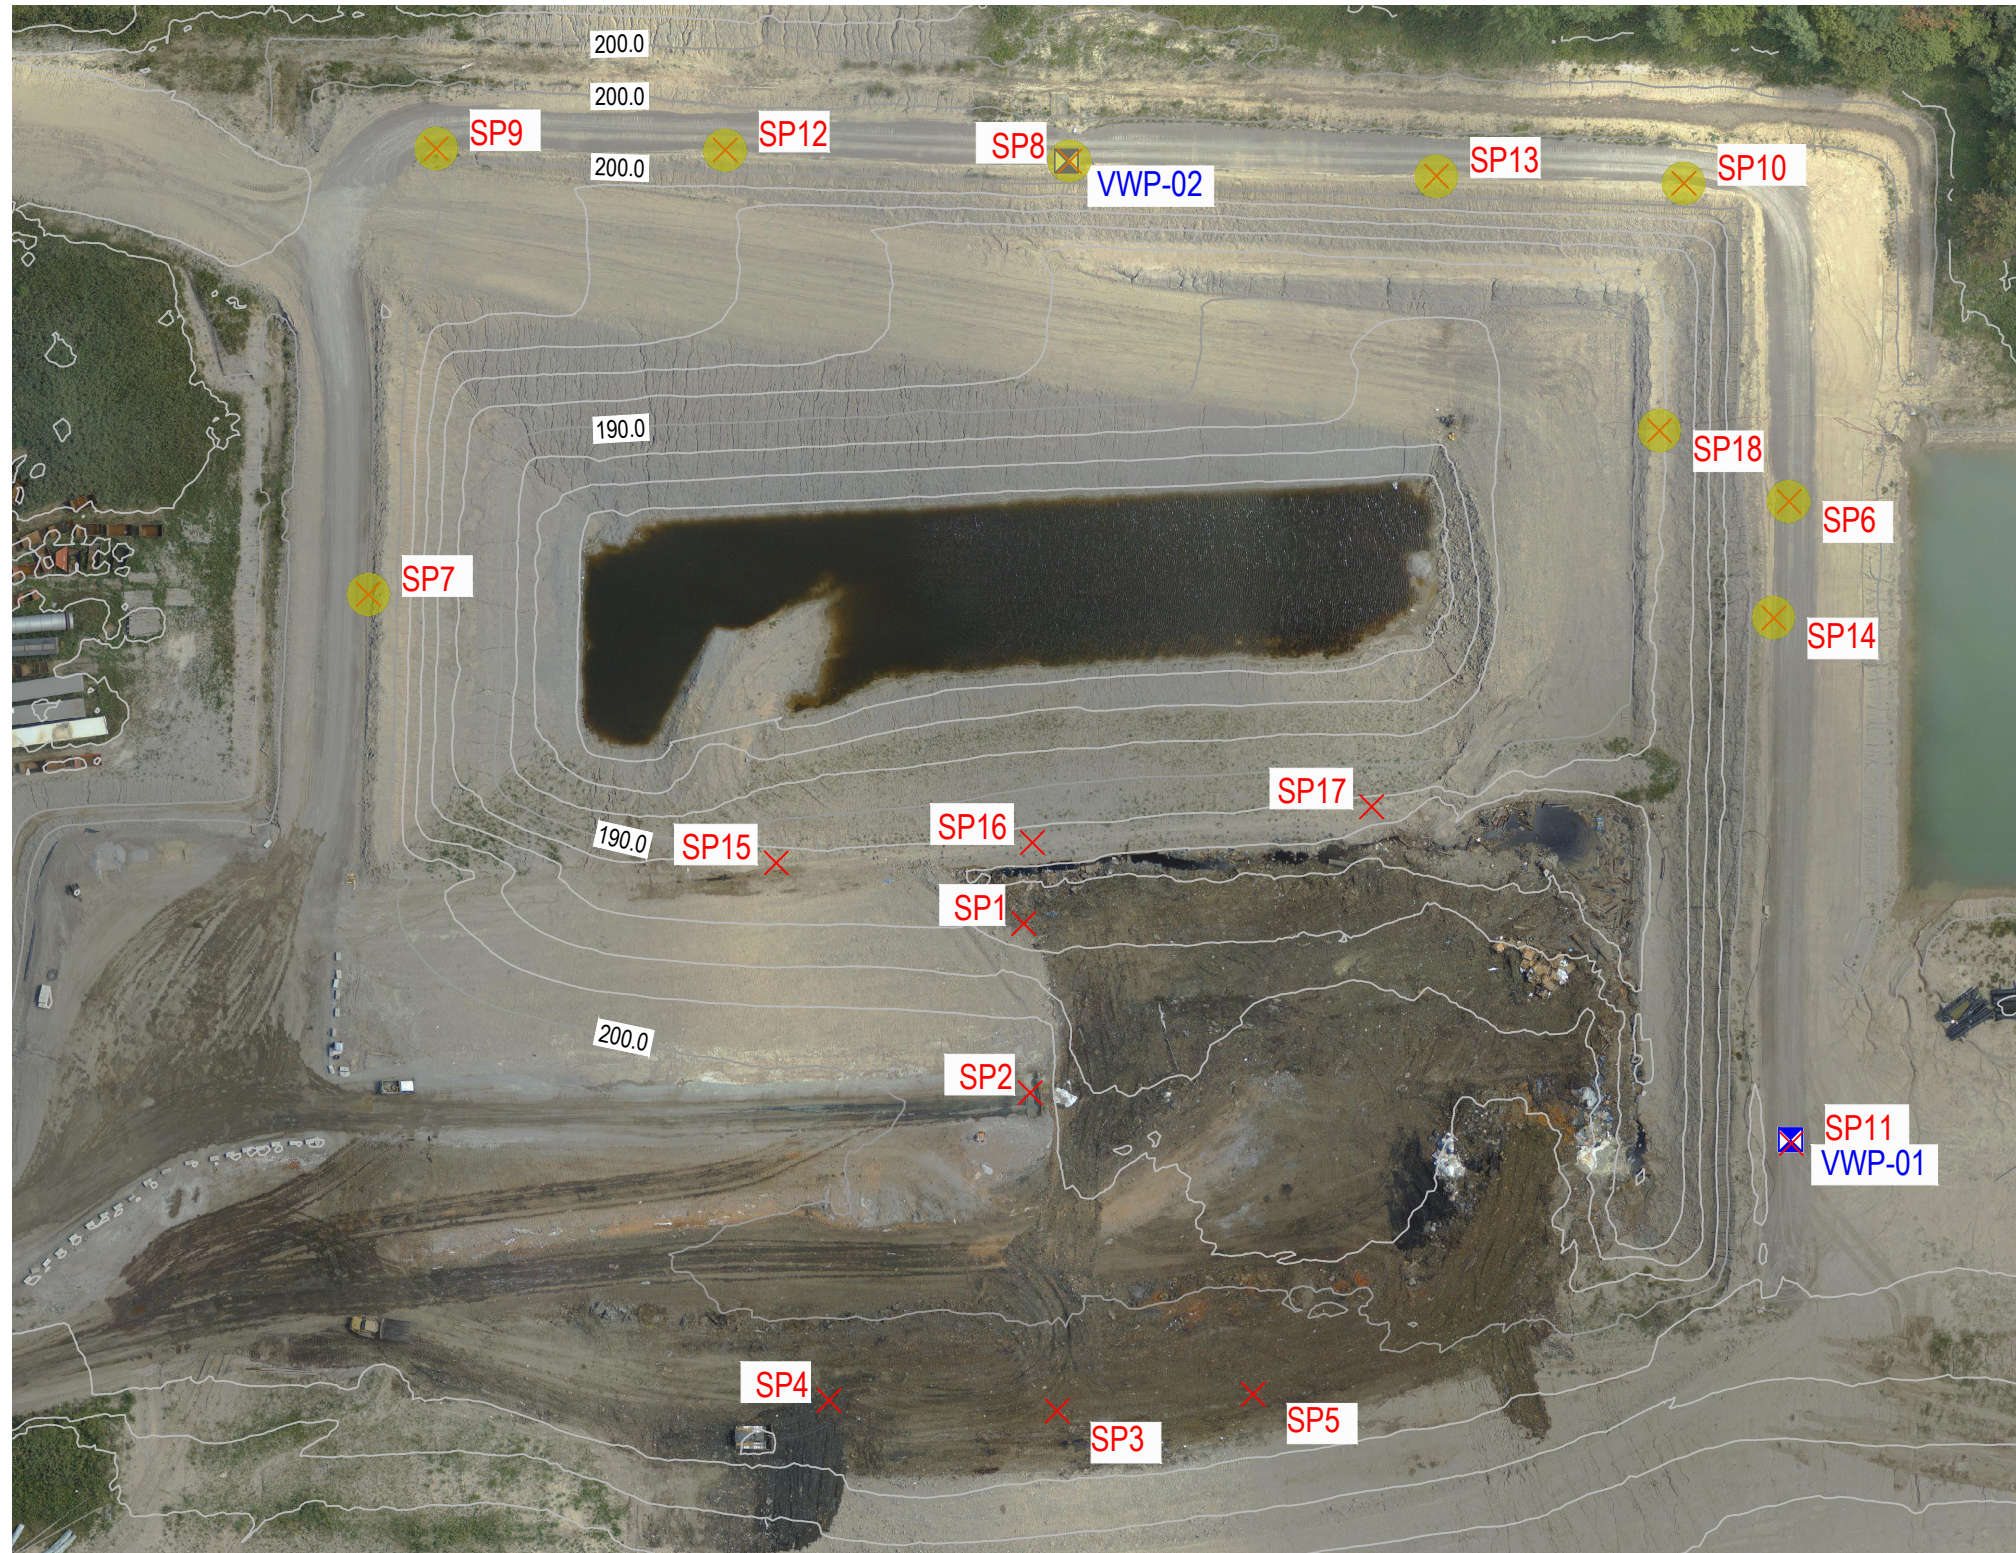
**Figure 1**

GHD recommended specific locations for surface movement monitoring around the perimeter of the cell, in our March 2, 2022 letter. Eighteen locations (SP-1 to SP-18) were recommended as shown on Figure 1. Survey pin locations SP-11, SP-15, SP-16, SP-17, and SP-18 were removed from the surveying program in 2023, as SP-11, SP, SP-15, SP-16, and SP-17 were located in the now filled western half of Cell 20-1, and SP-18 is not accessible due to waste placement.

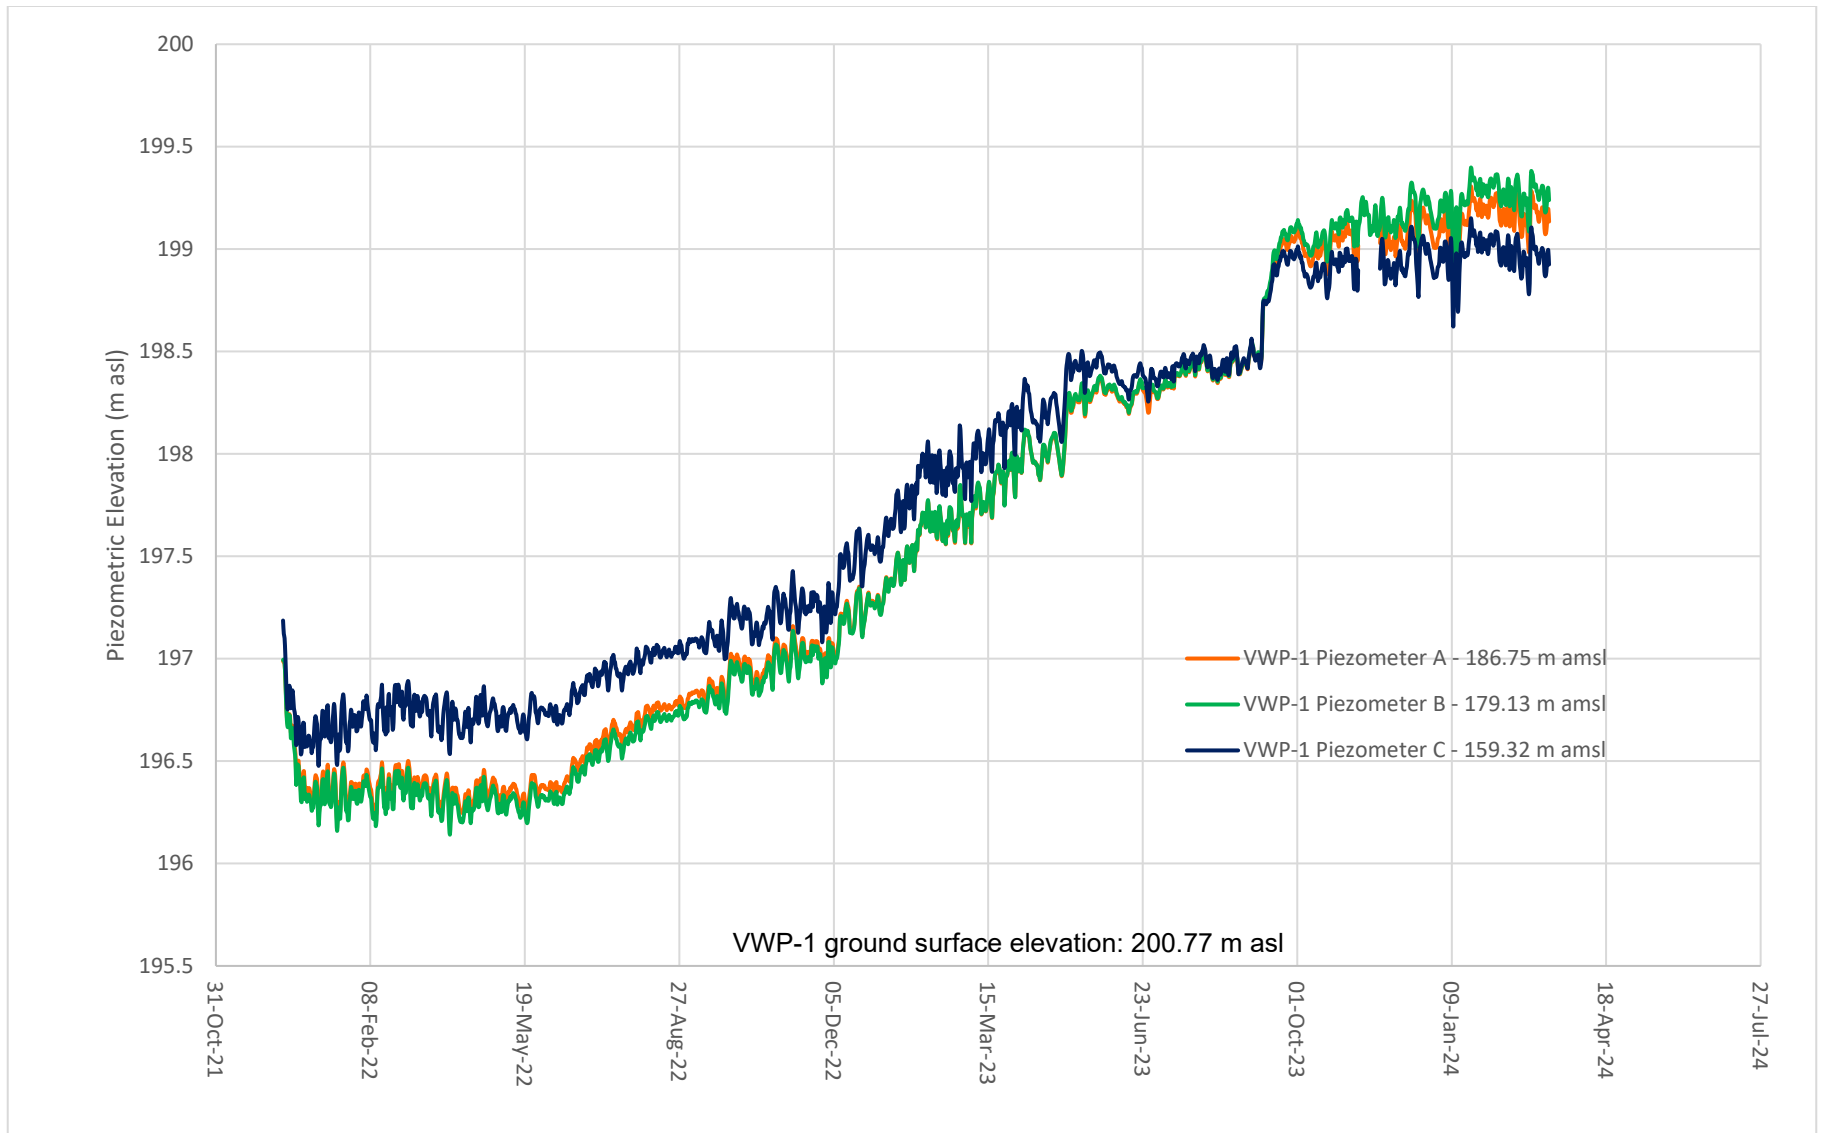
**Figure 2 – VWP-1 Piezometric Elevation Readings Cell 20-1**

Data plots of the piezometric surface collected to date are shown on Figures 2 and 3. The piezometric head pressures show a gradually increasing trend, due to waste placement and gradual stabilizing conditions. VWP-01 readings have shown a gradual steady increase due to the waste filling in the western half of Cell 20-1, with current piezometric reading just above elevation 199.0 m asl. The surface data logger storage box was hit by a pickup truck in the fall of 2023, causing the data loggers to become disconnected from the VWPs. GHD reconnected the data loggers in December 2023. Piezometric head readings for VWP-01 are shown on Figure 2.
