**April to December 2023 Geotechnical Inspections and Monitoring Summary**  
**Cell 20-1, Clean Harbors Lambton Landfill Site**  
**Corunna**

**Site Photographs**  
**Cell 20-1 2023 Geotechnical Inspections**  
**Clean Harbors Lambton Facility Landfill,**  
**Corunna**

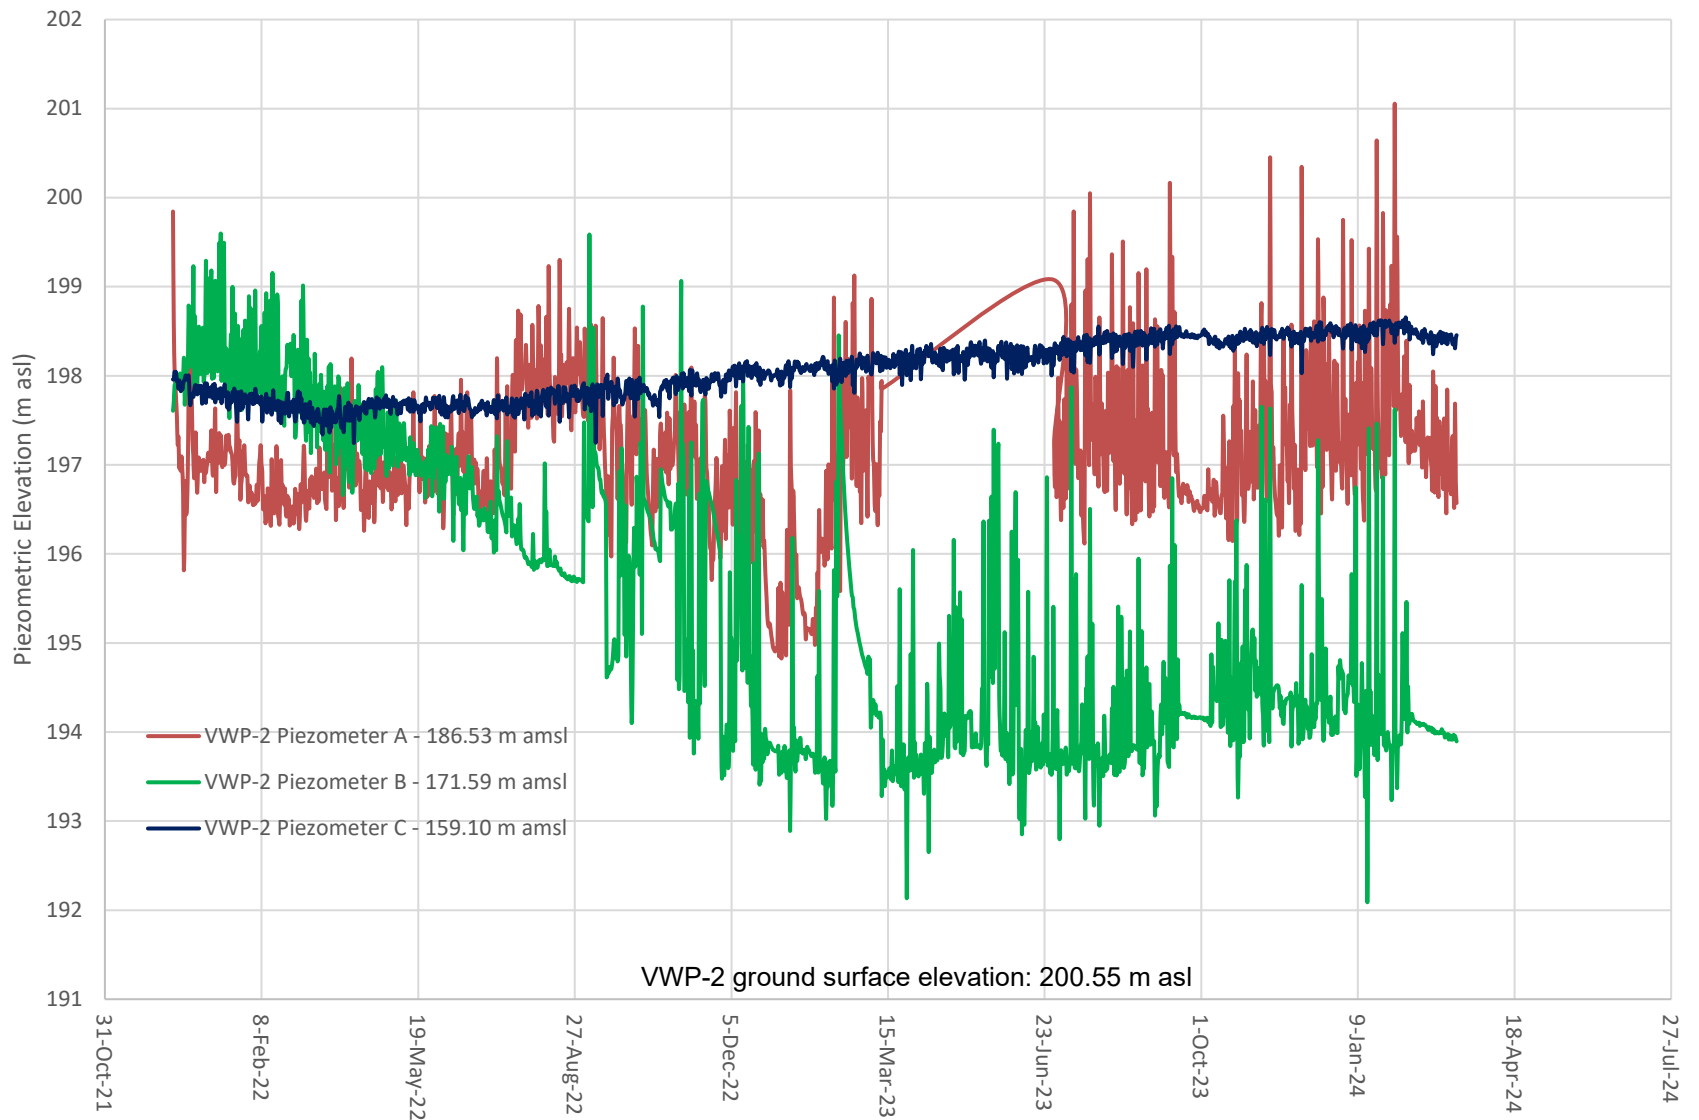
**Figure 3 – VWP-2 Piezometric Elevation Readings Cell 20-1**

VWP-02 is located on the east wall of the eastern half of Cell 20-1, which is currently being filled with waste. The lower piezometer is functioning well at VWP-02, and shows a slowly rising piezometric head of around 198.5 m asl. The upper two piezometers have shown less stable readings, but are reading slightly lower piezometric pressures than the deeper piezometer. Piezometric head for VWP-02 are shown on Figure 3.
